OZARK REGIONAL TRANSIT 2018 TRANSIT ASSET MANAGEMENT PLAN

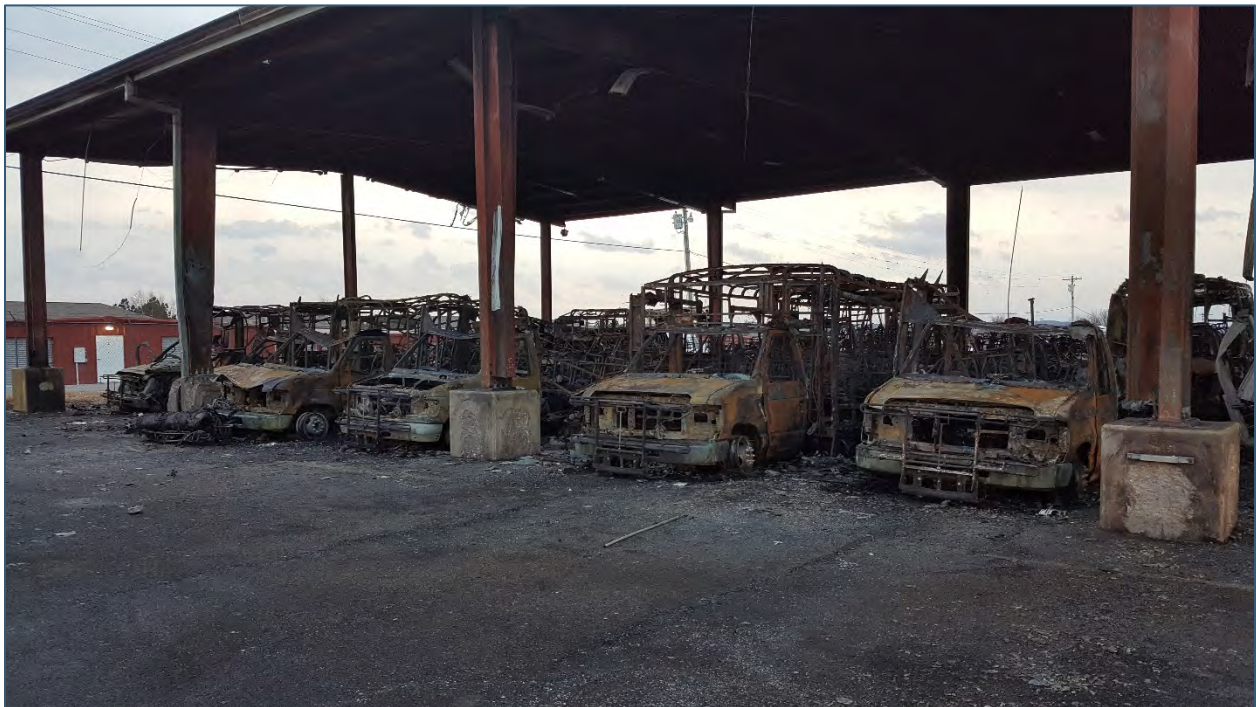
Figure 1.2 Buses Destroyed by January 10, 2017 Fire

On January 10, 2017 at about 1:10 a.m., twenty buses and two buildings were destroyed by a fire which has left ORT with a largely repurposed fleet to meet the transit needs until replacement vehicles can be ordered. ORT has been able to procure vehicles from all over the Southern and Eastern United States in order to limit the interruption of service to those who need it.

Due to the destruction of 20 buses by the fire, it has left ORT in a very poor State of Good Repair. ORT has applied for several grants in order to replace the destroyed buses, but acquiring both the funds and the buses is a time consuming process. ORT has been successful in obtaining a \$3.6 million grant from FTA to replace a portion of the fleet and those funds are reflected in the investment prioritization of this plan.

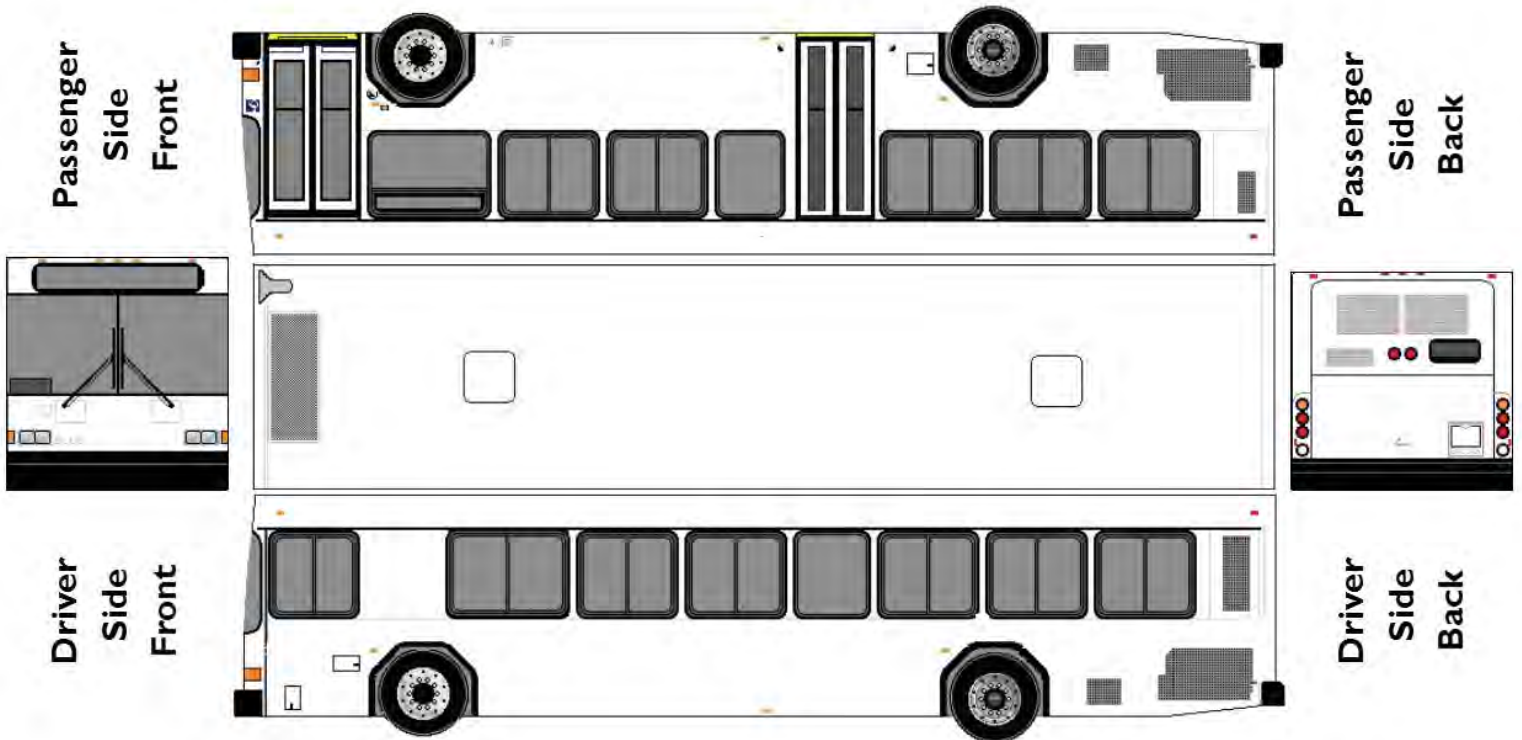
Lift not working

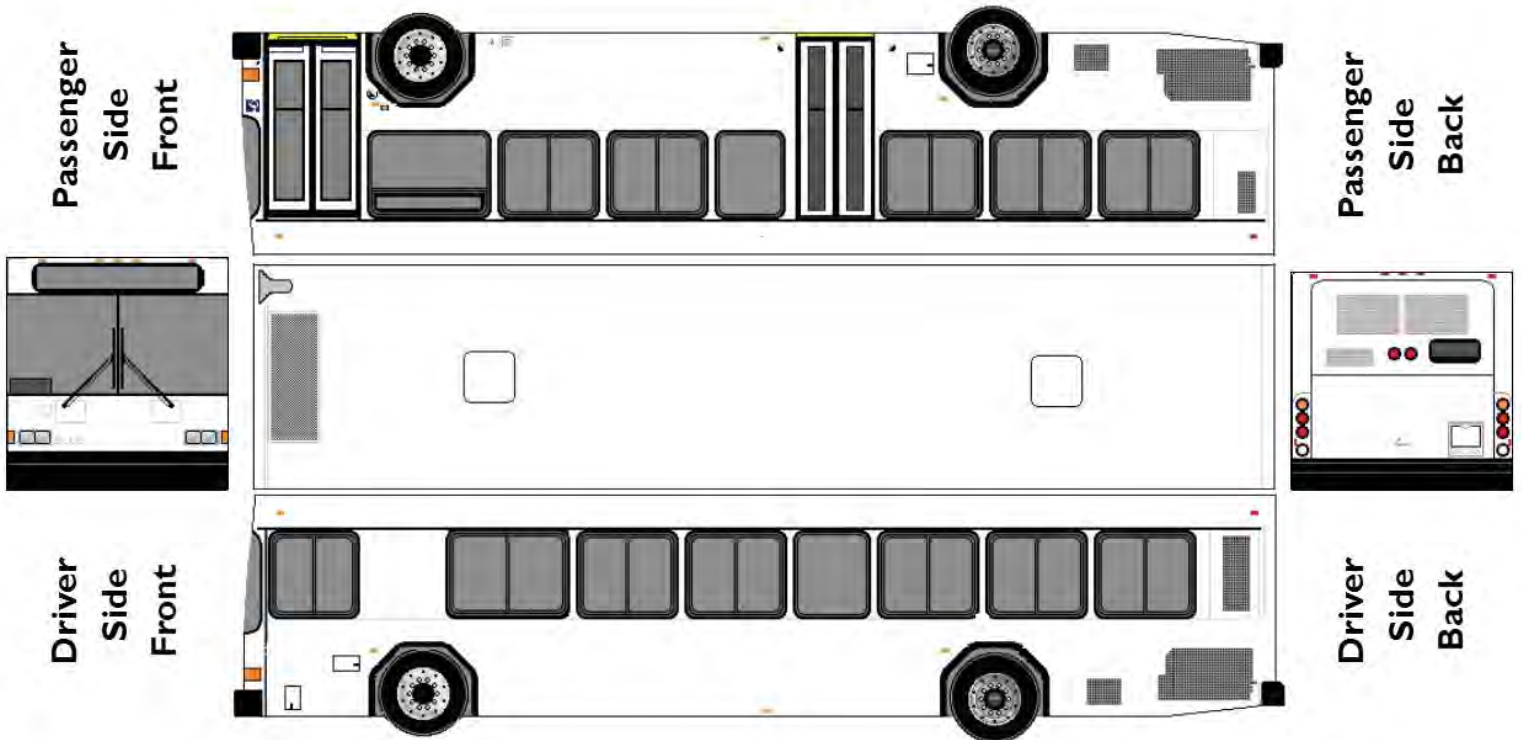
Lift not working

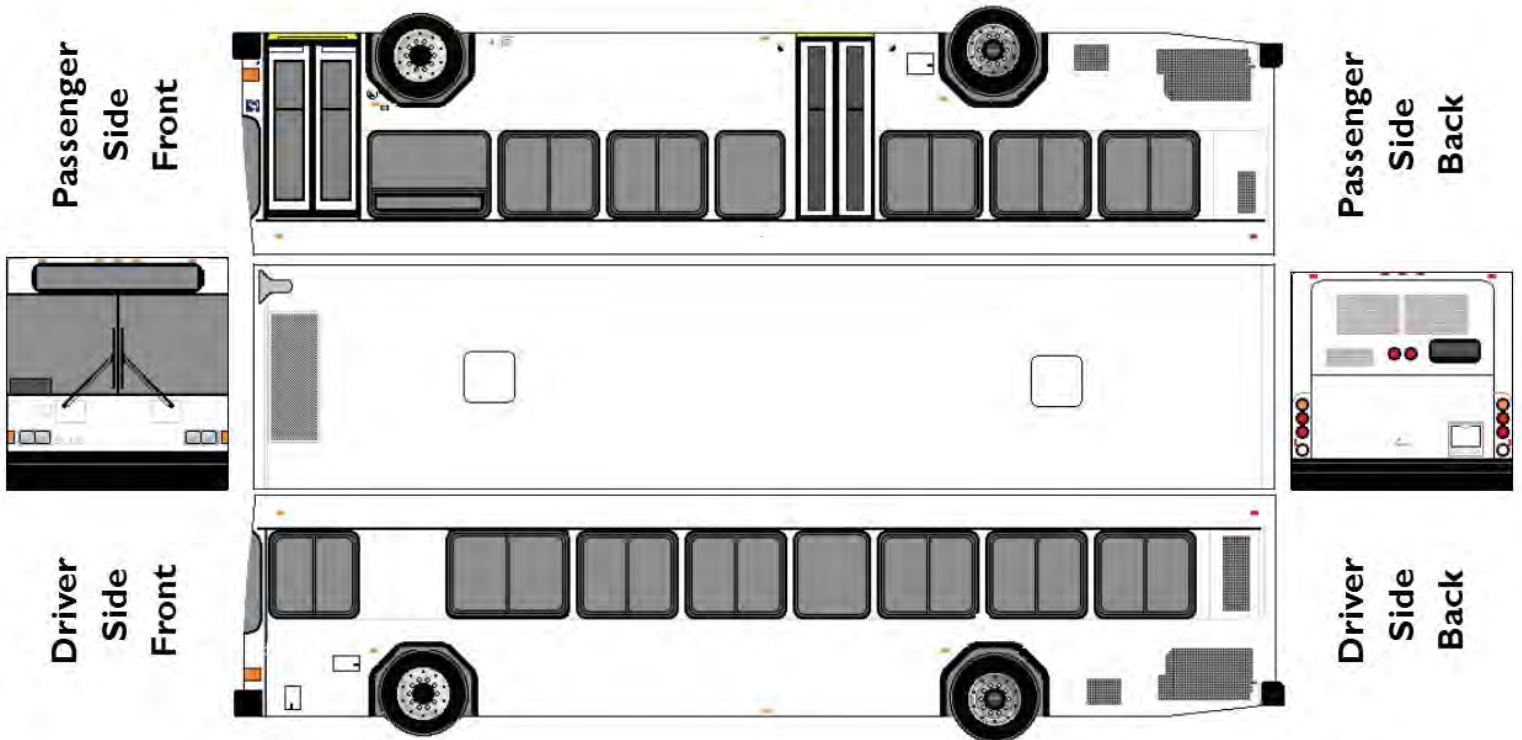
Lift not working

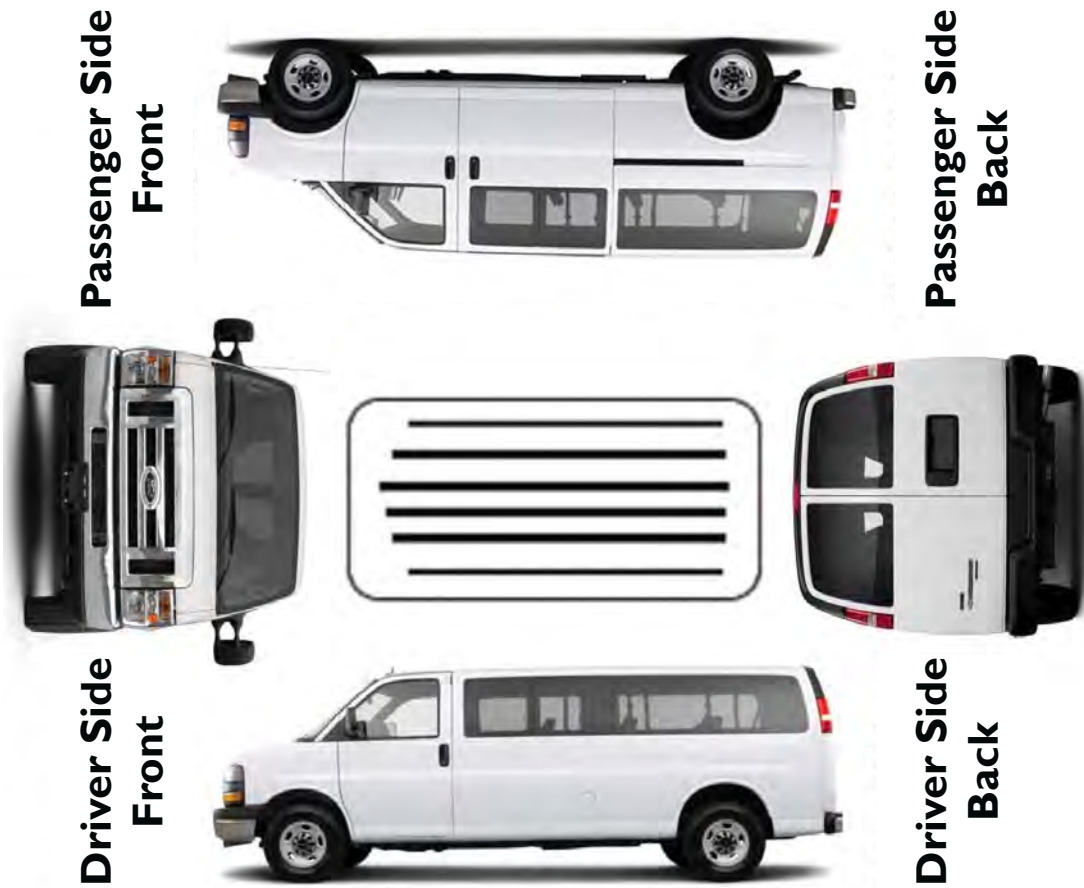
Vehicle is past its useful life.

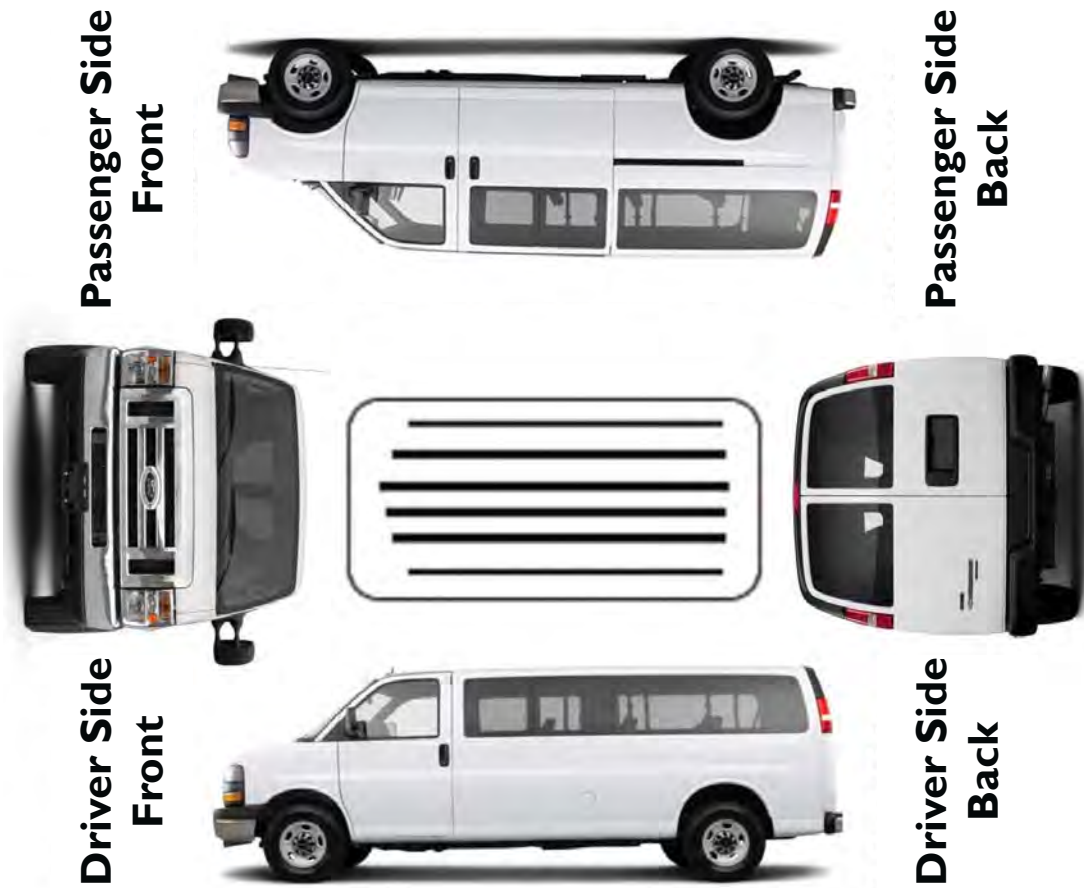
Vehicle is past its useful life.

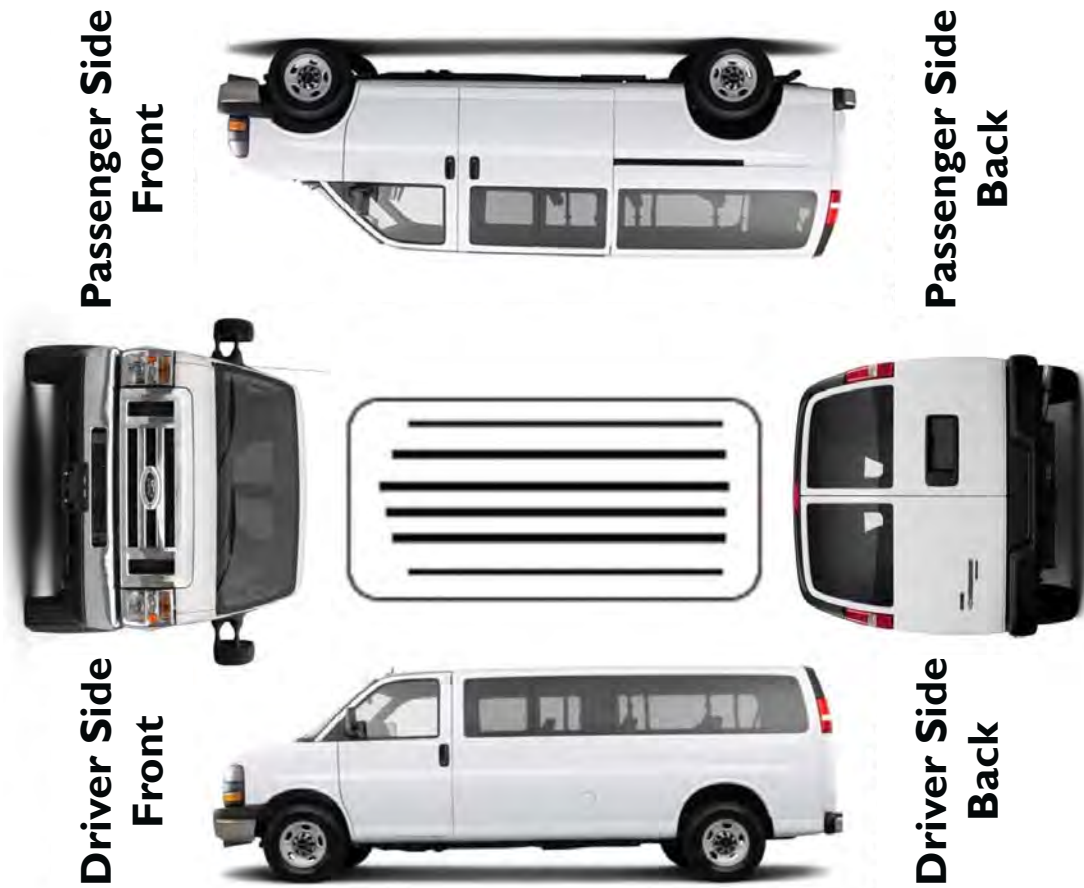
Vehicle is past its useful life.

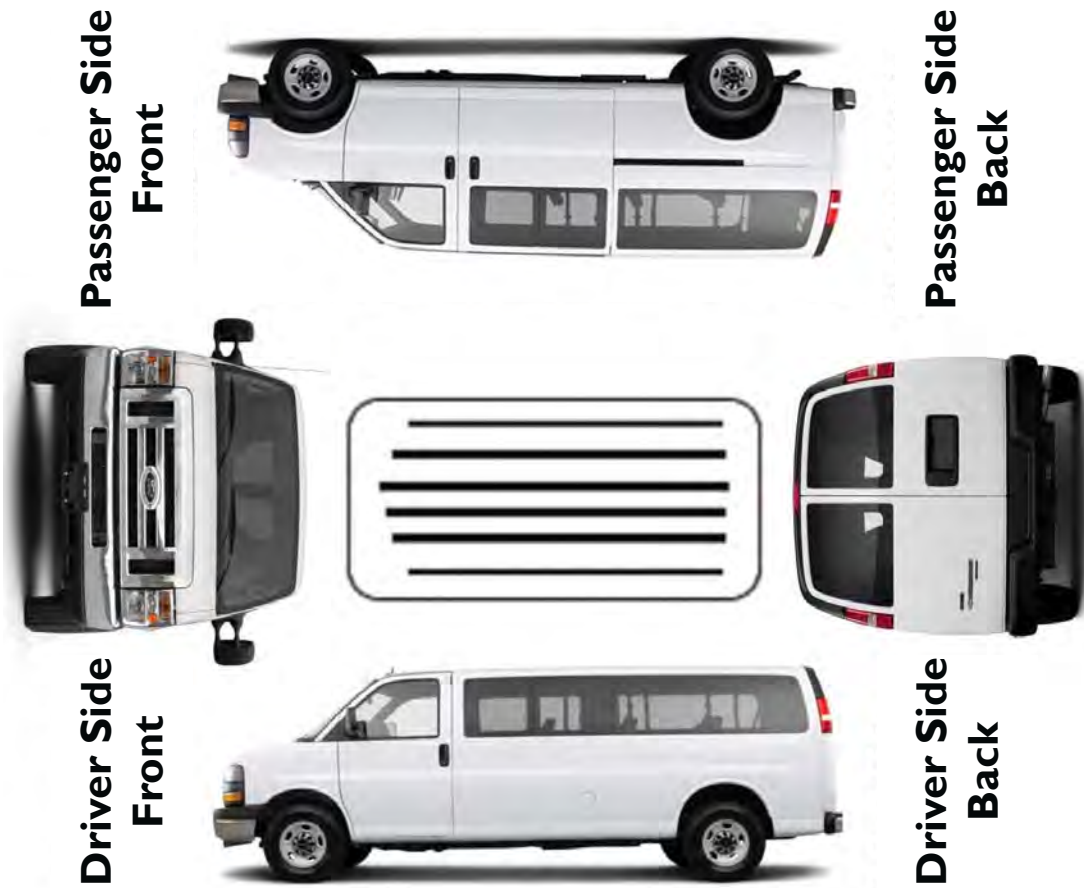
Vehicle is past its useful life.
